DEPARTMENT OF TRANSPORTATION**DIVISION OF ENGINEERING SERVICES**

Quality Assurance and Source Inspection

Contract #: 04-0120F4Cty: SF/ALA Rte: 80 PM: 13.2/13.9File #: 1.28**WELDING INSPECTION REPORT****Resident Engineer:**Siegenthaler, Peter**Address:** 333 Burma Road**City:** Oakland, CA 94607**Report No:** WIR-018514**Date Inspected:** 03-Dec-2010**Project Name:** SAS Superstructure**OSM Arrival Time:** 630**Prime Contractor:** American Bridge/Fluor Enterprises, a JV**OSM Departure Time:** 1500**Contractor:** American Bridge/Fluor Enterprises, a JV**Location:** Job Site**CWI Name:** Listed below.**CWI Present:** Yes No**Inspected CWI report:** Yes No N/A**Rod Oven in Use:** Yes No N/A**Electrode to specification:** Yes No N/A**Weld Procedures Followed:** Yes No N/A**Qualified Welders:** Yes No N/A**Verified Joint Fit-up:** Yes No N/A**Approved Drawings:** Yes No N/A**Approved WPS:** Yes No N/A**Delayed / Cancelled:** Yes No N/A**Bridge No:** 34-0006**Component:** S.A.S. Components**Summary of Items Observed:**

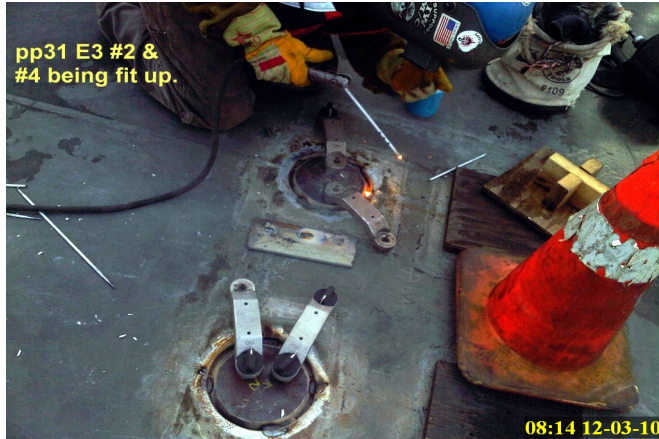
The QAI made observations of welding of the OBG deck hole patches on the East and West lines of the S.A.S. OBG structure. The QAI noted that these patches are being placed and welded into the deck access / ventilation holes and lifting lug holes. The QAI observed Earl Espinoza, ID 5824, fitting and welding lifting lug patches at PP31 E3 #2 and #4. The QAI noted that the Quality Control (QC) Inspector Pat Swain is monitoring the fitting and welding. The QAI noted that ABF-WPS-D15-1050A is being used for this welding. The QAI randomly measured the welding parameters and noted that they appeared to be conforming to the WPS requirements. This work was in progress at the end of the shift. See the attached photo.
